**Flood Control Project Maintenance
Levee Inspections**
LMA District Cover Sheet
Spring 2018 Levee Inspection Results

Reclamation District No. 0003 Grand Island

Spring 2018 Levee Inspection Results

| Waterway | | | Bank | Unit Miles |
|--|---|---|---|---|
| Unit No. 01 Left Bank Steamboat Slough | | | Left | 10.95 |

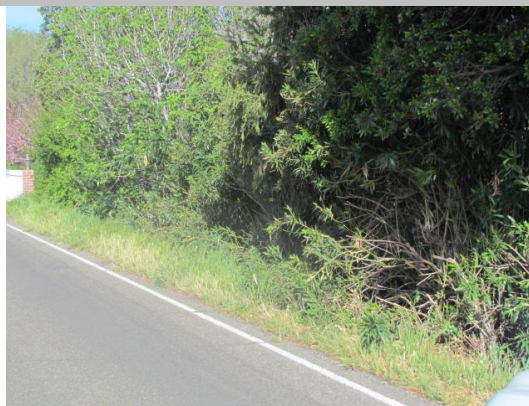
Photo 1 of 1 : SP_2018_RD0003_25_156_20180305_00136.jpg

| Oleander blocking view of landside slope. | | | | | |

Looking west at dense landscaping on landward shoulder and slope.

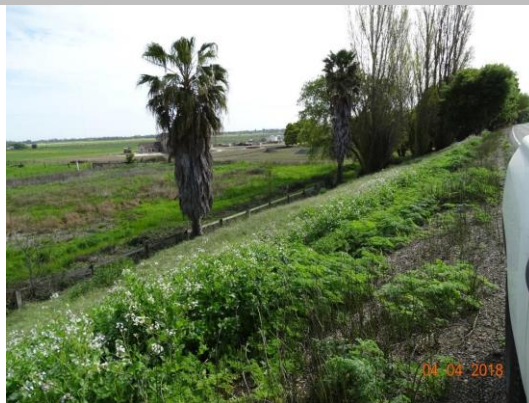
Photo 1 of 1 : SP_2018_RD0003_25_182_20180404_00292.jpg

Heavy vegetation on landside slope prevents inspection.

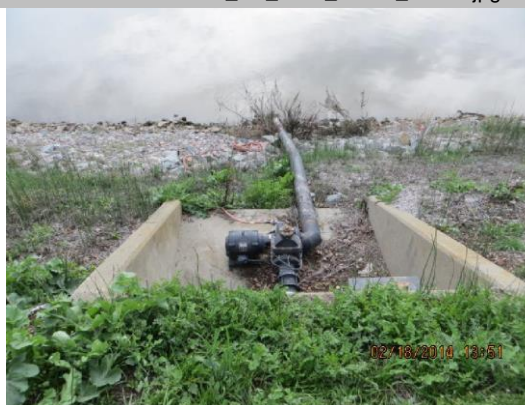
Photo 1 of 3 : UCIP_SP_2018_30406_55927.jpg

| FS_ID:30406 DS_ID:22281 EP_NO: N/A Repair Type: Non-Urgent Crossing Status: Found UCIP Comments: Actuator for Gate valve is broken off. FIELD_STRUCT_DESC: 8-inch steel irrigation discharge pipe through the levee, invert elevation 6.5 feet below the crown. Pipe reduced to 6 inches on the slopes. Pump and gate valve on a concrete pad on the waterside (WS) slope. Siphon breaker on the landside (LS) slope. (DWR Bank Protection Project, Drawing No. 50-4-3741, Sheet 21 - Castanho). [Additional Reference(s): DWR Levee Log, 1993, USACE Sacramento O&M Manual 104, February 1960, (RM 25.09), 6-inch pipe referenced]. FS Date: 2/18/2014 | | | | | |

Pump, gate valve, and concrete pad on WS slope.

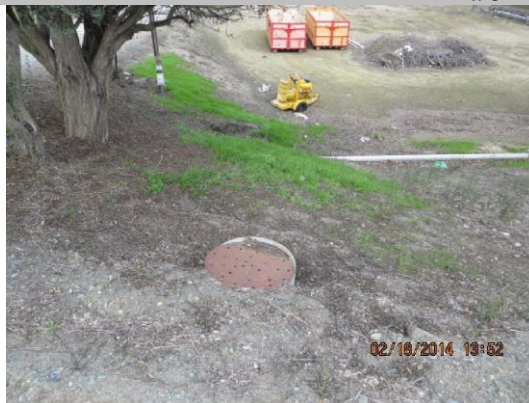
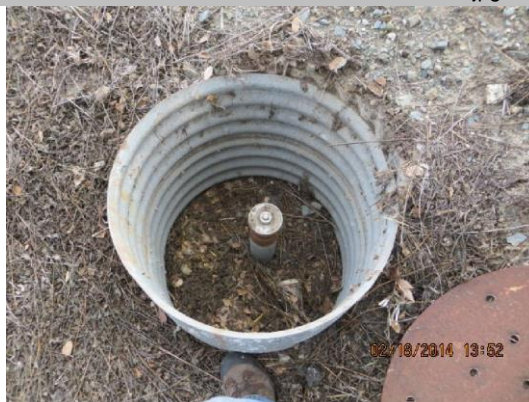
Siphon Breaker in CMP riser on LS shoulder.

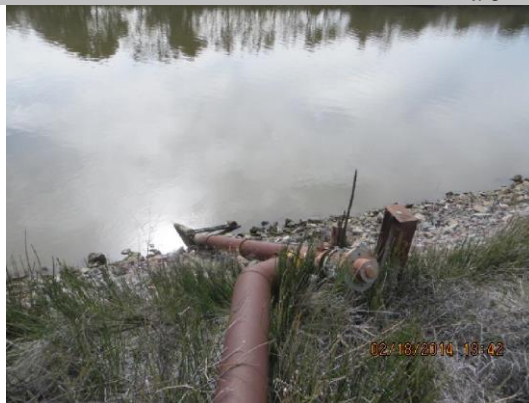
Photo 2 of 2 : UCIP_SP_2018_30404_55923.jpg

| FS_ID:30404 DS_ID:22282 EP_NO: 3670 Repair Type: Non-Urgent Crossing Status: Found UCIP Comments: Appears abandoned as no pipe, siphon breaker, or standpipe visible on LS toe. If so, it should be abandoned properly. FIELD_STRUCT_DESC: 12-inch steel irrigation discharge pipe through the levee, 3.8 feet below the crown. Slant pump on the waterside (WS) slope. Siphon breaker on the landside (LS) shoulder. (Plans to remove an old centrifugal pump and suction pipe, to install a new propeller pump 40 feet in length along the slope of the levee, to install necessary foundation piling to support the pump, and to connect to present pipe through the levee authorized under Permit No. 3670, 1961 - Russell G. Graham. Plans to replace a section of an existing irrigation pipe with a 12-inch steel pipe through the crown of the levee authorized under Permit No. 17837, 2004 - Ron Galindo). [Additional Reference(s): DWR Levee Log, 1993]. FS Date: 2/18/2014 | | | | | | |

Pipe and slant pump visible on WS slope.

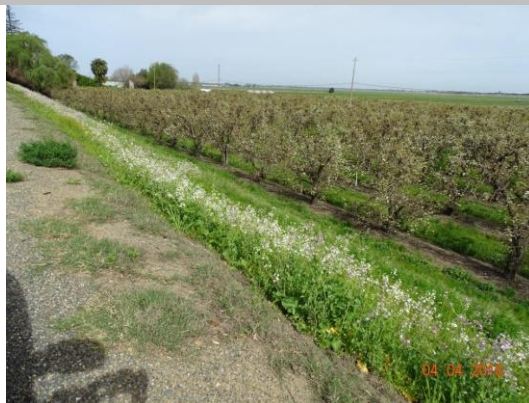
Photo 1 of 1 : SP_2018_RD0003_25_167_20180404_00295.jpg

Heavy vegetation on Inside slope prevents inspection.

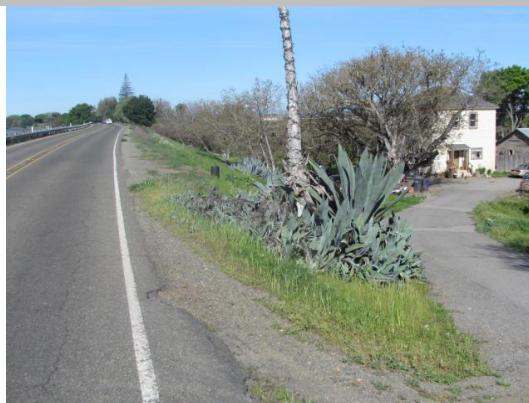
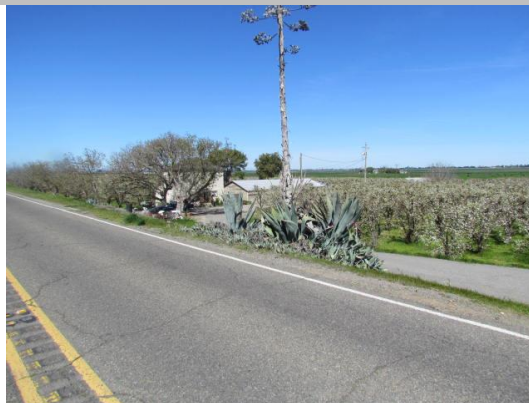
| Century plant on landside shoulder. | | | | | |

Looking west at century plant on landward slope. (Spring 2015)

Looking northwest at century plant on landward shoulder and slope.

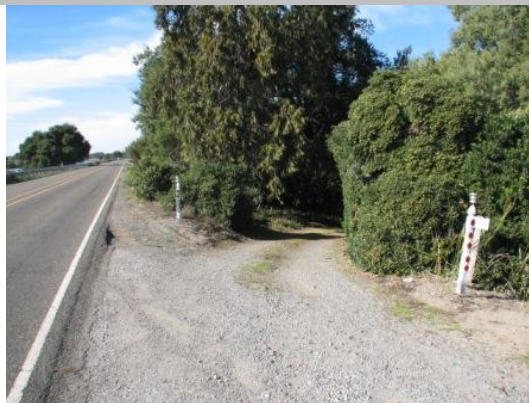
Photo 1 of 1 : SP_2018_RD0003_25_66_20180305_00051.jpg

Landscaping on levee slope and toe obstructs access and visibility.

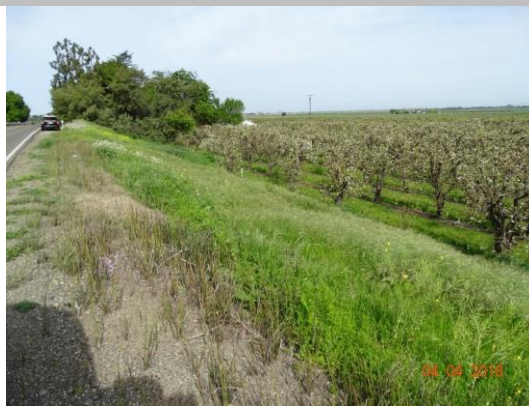
Photo 1 of 1 : SP_2018_RD0003_25_163_20180404_00290.jpg

Tall landside vegetation prevents inspection.

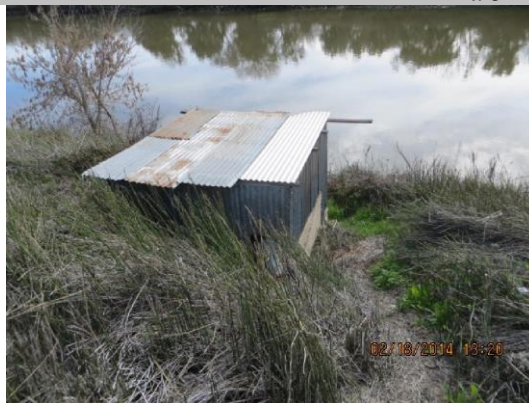
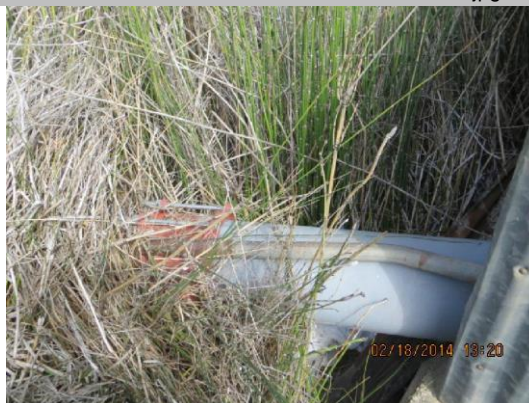
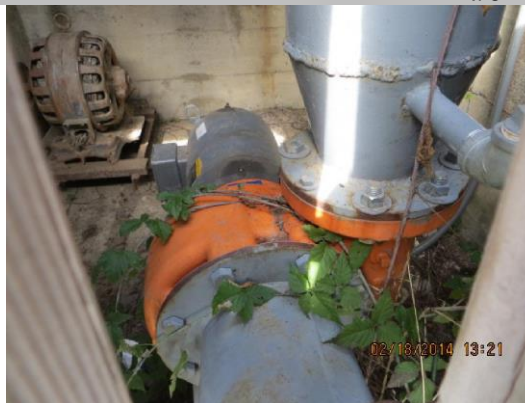
FS_ID:30391
DS_ID:22284
EP_NO: 9442
Repair Type: Non-Urgent
Crossing Status: Found
UCIP Comments: Good candidate for video inspection.
FIELD_STRUCT_DESC: 8-inch steel irrigation discharge pipe through the levee, invert elevation 7.5 feet below the crown. Pump and gate valve on the waterside (WS) slope. 4-foot by 4-foot concrete distribution box at the landside (LS) toe, next to a power pole and meter. 1.5-inch electrical conduit through the levee at the same location. (Retention of an irrigation pumping plant, centrifugal pump, and accessories in a corrugated metal shed on the WS levee slope and an 8-inch pipe through the levee above the floodplain authorized under Automatic Board Order (ABO) issued as Permit No. 9442, 1974 - Frank Gwerder). [Additional Reference(s): DWR Levee Log, 1993. USACE Sacramento O&M Manual 104, February 1960, (RM 25.74), 6-inch pipe referenced].
FS Date: 2/18/2014

Pump and gate valve in pumphouse on WS slope.

Pipe and conduit visible on WS slope.

Pump in pumphouse on WS slope.

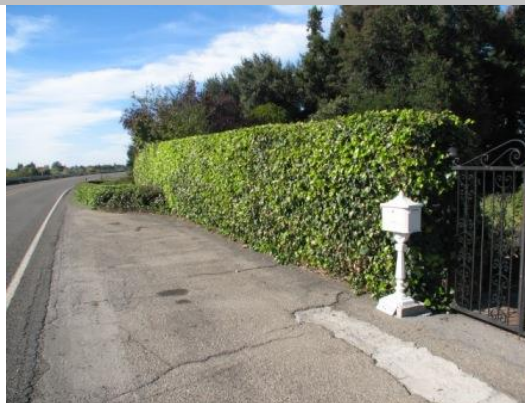
Photo 1 of 1 : SP_2018_RD0003_25_67_20180305_00052.jpg

Landscaping on levee slope obstructs access and visibility.

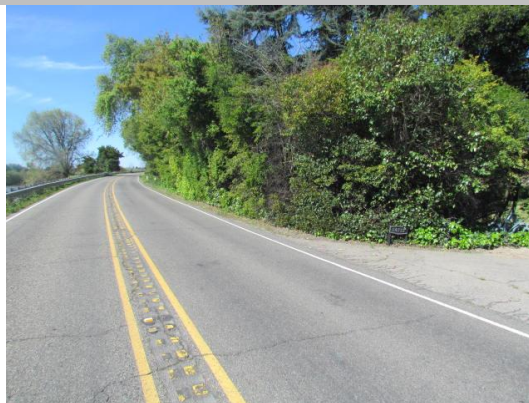
Photo 1 of 1 : SP_2018_RD0003_25_68_20180305_00053.jpg

Looking west at dense landscaping on landward shoulder and slope.

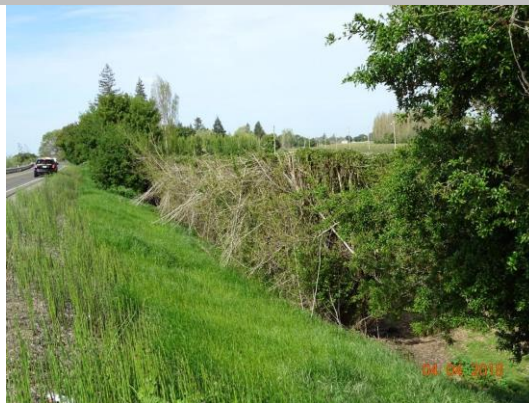
Photo 1 of 1 : SP_2018_RD0003_25_160_20180404_00289.jpg

| Row of closely-spaced trees at landside toe inhibits inspection and prevents access. | | | | | |

Trees at landside toe.

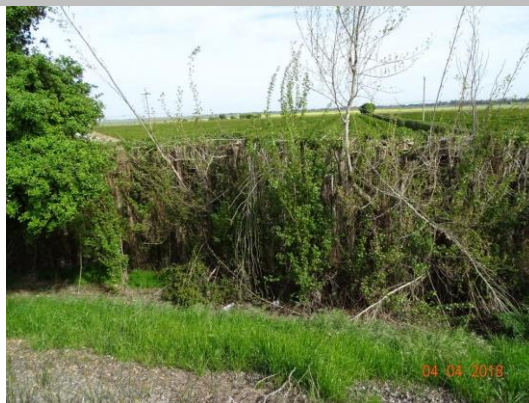
Photo 1 of 1 : SP_2018_RD0003_25_153_20180404_00288.jpg

| Row of closely-spaced trees at landside toe inhibits inspection and prevents access. | | | | | |

Row of trees at landside toe.

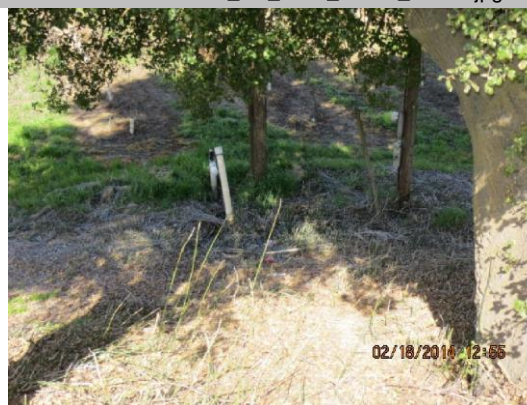
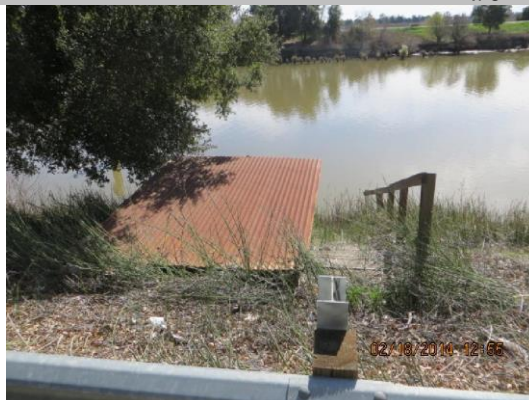
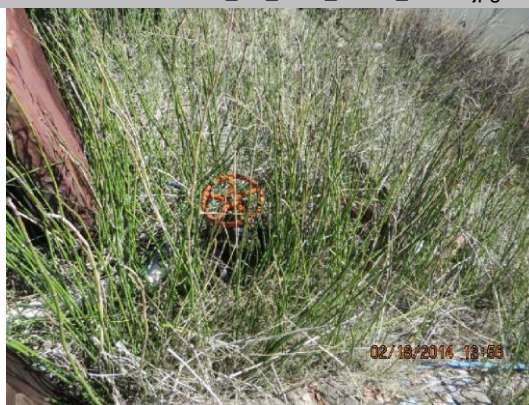
| FS_ID:30364 DS_ID:22288 EP_NO: N/A Repair Type: Non-Urgent Crossing Status: Found UCIP Comments: Annular space not grouted. FIELD_STRUCT_DESC: 8-inch steel irrigation discharge pipe through the levee, invert elevation 6.7 feet below the crown. A 4-inch polyvinyl chloride (PVC) pipe is sleeved through the 8-inch pipe. Pump and gate valve in a pump house on the waterside (WS) slope. (Johnson). [Additional Reference(s): DWR Levee Log, 1993. USACE Sacramento O&M Manual 104, February 1960, (RM 26.25)]. FS Date: 2/18/2014 | | | | | | |

PVC pipe, pole, and meter visible on LS toe.

Pipe visible in abandoned pumphouse on WS slope.

Shutoff valve at pump on WS slope.

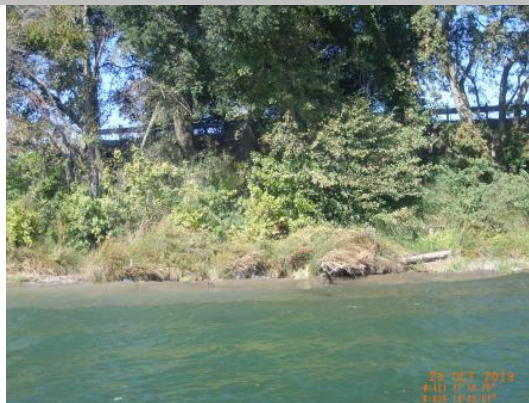
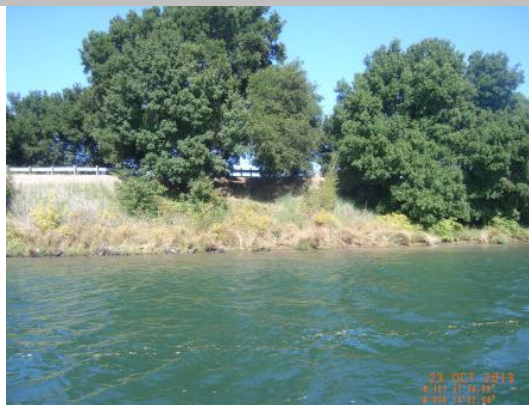
| 2009 - Hole left in levee toe from a fallen tree. Could be repaired under maintenance. 2010 - Minor new erosion. 2015: Minor new erosion at toe. [2015 Site ID: SAC_26-3_R] | | | | | |

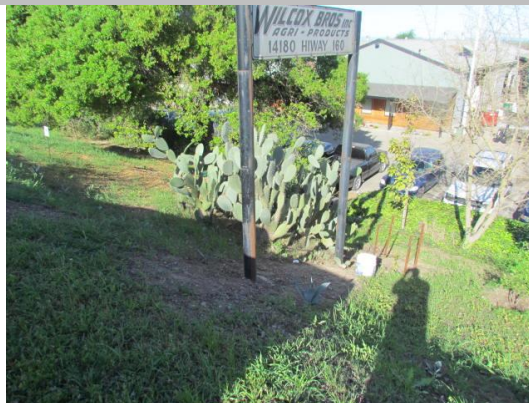
Photo 1 of 1 : SP_2018_RD0003_25_155_20180305_00135.jpg

| Cactus on landside slope. | | | | | |

Looking southwest at cactus on landward slope and toe.

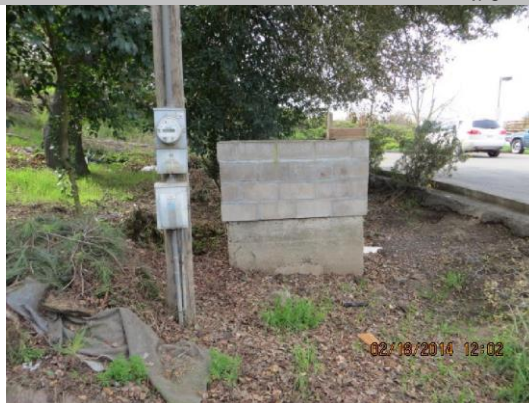
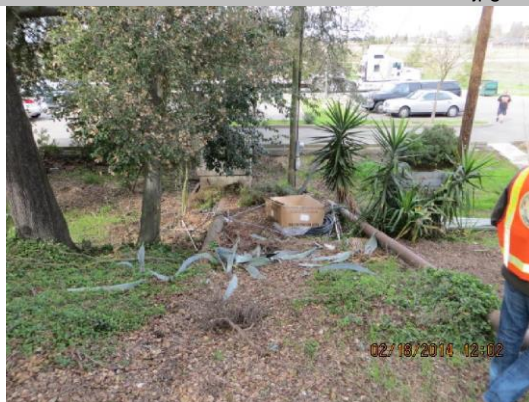
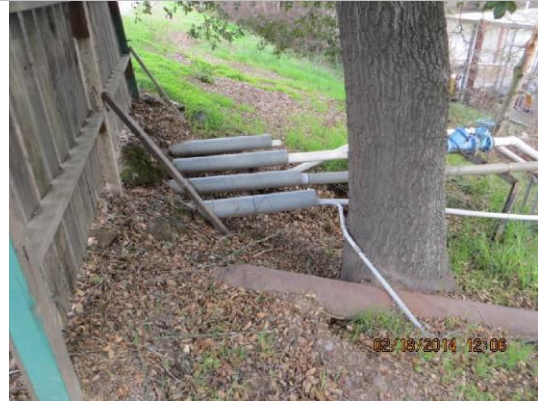
| FS_ID:30363 DS_ID:22290 EP_NO: 665 Repair Type: Non-Urgent Crossing Status: Found UCIP Comments: Appears abandoned and if so should be done so properly. FIELD_STRUCT_DESC: 10-inch steel irrigation discharge pipe through the levee, invert elevation 2.8 feet below the crown. Pump on a pile structure in the river. 5-foot by 5-foot concrete distribution box at the landside (LS) toe with a meter pole. (Plans for the installation of a 10-inch, 10-gauge discharge pipe through the levee Permit No. 665, 1936 - C. T. Vollman). [Additional Reference(s): DWR Levee Log, 1993. USACE Sacramento O&M Manual 104, February 1960, (RM 26.62)]. FS Date: 2/18/2014 | | | | | | |

Concrete distribution box and meter on pole on LS toe.

Pipe and distro box visible at left side of photo.

Pipe visible in foreground next to oak.

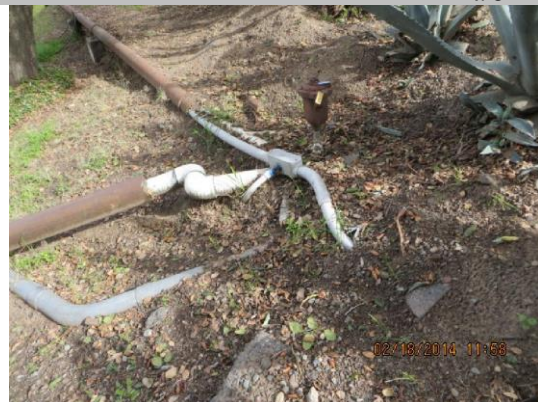
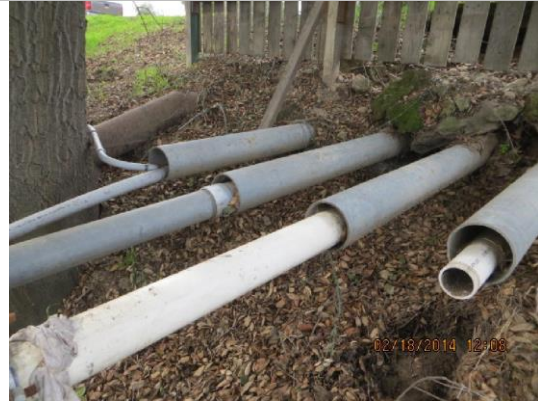
| FS_ID:30352 DS_ID:22320 EP_NO: 16053 Repair Type: Non-Urgent Crossing Status: Found UCIP Comments: Annular space not grouted. FIELD_STRUCT_DESC: 1 of 4: 6-inch galvanized iron electrical conduit through the levee, 3 feet below the crown. 2-inch polyvinyl chloride (PVC) and 1-inch PVC electrical conduits sleeved through the 6-inch conduit. (Plans to install four 6-inch pipe casings through the levee authorized under Permit No. 16053, 1993 - Vollman-Clark Ranch, DCC Engineering Company, Inc). FS Date: 2/18/2014 | | | | | |

Electrical conduit visible on LS slope.

Both electrical conduits and 6-inch galvanized iron conduit visible at left in photo.

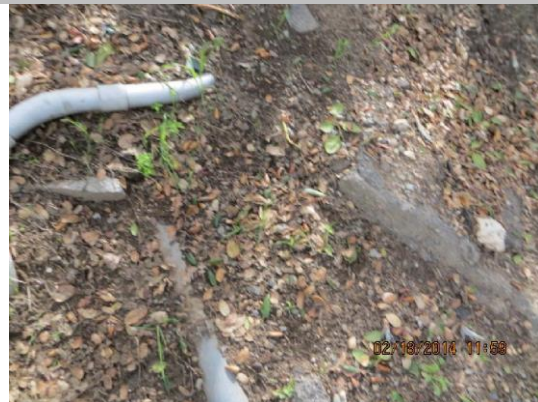
Photo 1 of 3 : UCIP_SP_2018_30353_55827.jpg

| FS_ID:30353 DS_ID:22356 EP_NO: 16053 Repair Type: Non-Urgent Crossing Status: Found UCIP Comments: Annular space not grouted. FIELD_STRUCT_DESC: 2 of 4: 6-inch galvanized iron electrical conduit through the levee, 3 feet below the crown. 4-inch steel electrical conduit sleeved through the 6-inch conduit. Electrical panel visible on the landside (LS) toe. (Plans to install four 6-inch pipe casings through the levee authorized under Permit No. 16053, 1993 - Vollman-Clark Ranch, DCC Engineering Company, Inc). FS Date: 2/18/2014 | | | | | |

Electrical conduit visible on LS slope.

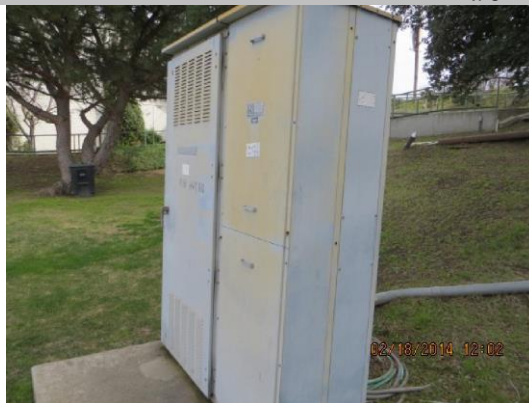
Photo 2 of 3 : UCIP_SP_2018_30353_55826.jpg

| FS_ID:30353 DS_ID:22356 EP_NO: 16053 Repair Type: Non-Urgent Crossing Status: Found UCIP Comments: Annular space not grouted. FIELD_STRUCT_DESC: 2 of 4: 6-inch galvanized iron electrical conduit through the levee, 3 feet below the crown. 4-inch steel electrical conduit sleeved through the 6-inch conduit. Electrical panel visible on the landside (LS) toe. (Plans to install four 6-inch pipe casings through the levee authorized under Permit No. 16053, 1993 - Vollman-Clark Ranch, DCC Engineering Company, Inc). FS Date: 2/18/2014 | | | | | | |

Electrical panel visible on LS toe.

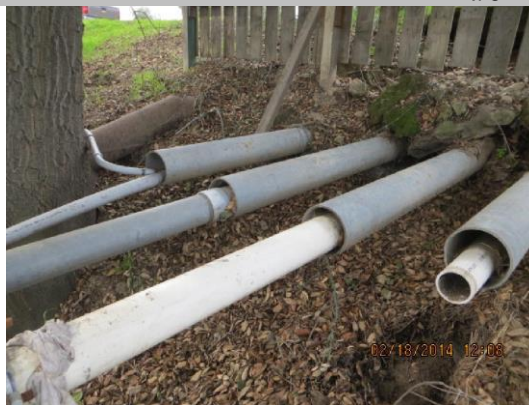
Photo 3 of 3 : UCIP_SP_2018_30353_55825.jpg

Electrical conduit visible at WS shoulder at 6-inch conduit it is sleeved through.

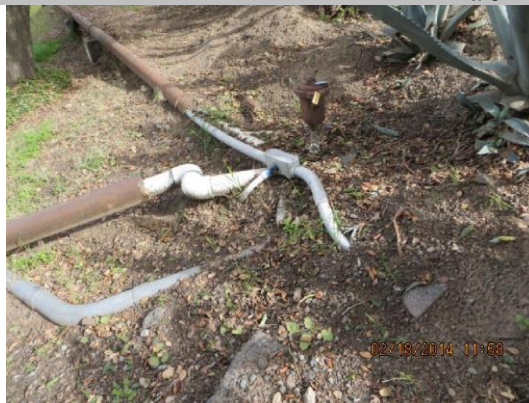
Photo 1 of 2 : UCIP_SP_2018_30356_55833.jpg

| FS_ID:30356 DS_ID:22357 EP_NO: 16053 Repair Type: Non-Urgent Crossing Status: Found UCIP Comments: Annular space not grouted. FIELD_STRUCT_DESC: 3 of 4: 6-inch galvanized iron water line conduit through the levee, 3 feet below the crown. 4.5-inch polyvinyl chloride (PVC) water line is sleeved through the 6-inch conduit. Vent on the landside (LS) slope. Backflow preventer with two shutoff valves visible on the waterside (WS) shoulder. (Plans to install four 6-inch pipe casings through the levee authorized under Permit No. 16053, 1993 - Vollman-Clark Ranch, DCC Engineering Company, Inc). FS Date: 2/18/2014 | | | | | |

Vent or siphon breaker visible on LS shoulder along with 4.5-inch PVC waterline.

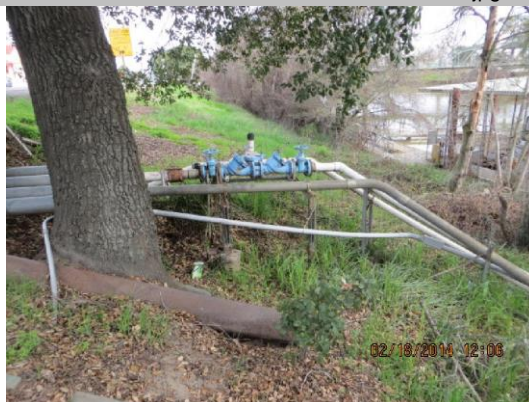
Photo 2 of 2 : UCIP_SP_2018_30356_55832.jpg

Blue backflow preventer with two shutoff valves visible on WS shoulder.

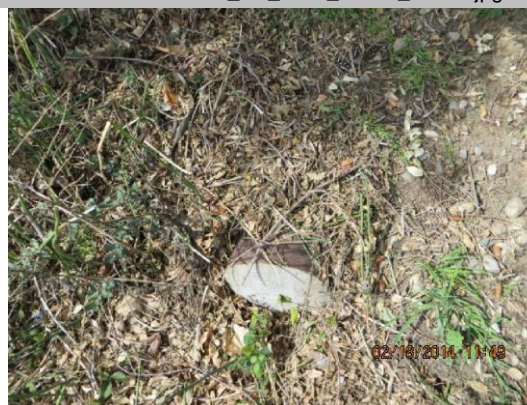
Photo 1 of 3 : UCIP_SP_2018_30345_55789.jpg

| FS_ID:30345 DS_ID:22292 EP_NO: N/A Repair Type: Non-Urgent Crossing Status: Found UCIP Comments: Depression over pipe at crown may indicate pipe is failing. FIELD_STRUCT_DESC: *ABANDONED* 12-inch welded steel irrigation discharge pipe through the levee, invert elevation 5 feet below the crown. Pipe was cut off and filled with concrete on the waterside (WS) slope. Pipe was cut off and left open on the WS end. (Plans to install a 7.5-horsepower angle mounted irrigation pump and a 12-inch, 10-gauge welded steel discharge pipe through the levee authorized under Permit No. 5428, 1966 - Grand Island Farms). [Additional Reference(s): DWR Levee Log, 1993, 10-inch pipe referenced. USACE Sacramento O&M Manual 104, February 1960, (RM 26.80), 10-inch pipe referenced]. FS Date: 2/18/2014 | | | | | | |

Pipe with concrete fill on WS slope.

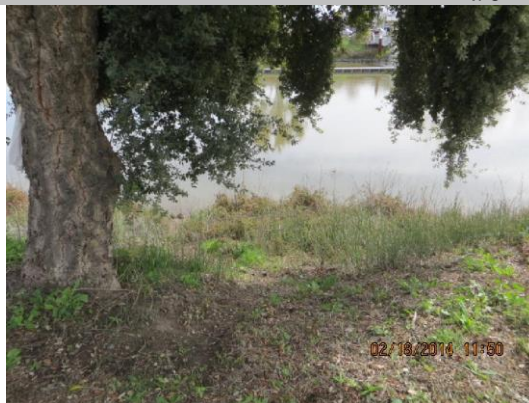
Photo 2 of 3 : UCIP_SP_2018_30345_55788.jpg

FS_ID:30345
DS_ID:22292
EP_NO: N/A
Repair Type: Non-Urgent
Crossing Status: Found
UCIP Comments: Depression over pipe at crown may indicate pipe is failing.
FIELD_STRUCT_DESC: *ABANDONED* 12-inch welded steel irrigation discharge pipe through the levee, invert elevation 5 feet below the crown. Pipe was cut off and filled with concrete on the waterside (WS) slope. Pipe was cut off and left open on the WS end. (Plans to install a 7.5-horsepower angle mounted irrigation pump and a 12-inch, 10-gauge welded steel discharge pipe through the levee authorized under Permit No. 5428, 1966 - Grand Island Farms). [Additional Reference(s): DWR Levee Log, 1993, 10-inch pipe referenced. USACE Sacramento O&M Manual 104, February 1960, (RM 26.80), 10-inch pipe referenced].
FS Date: 2/18/2014

Pipe visible just downstream and downhill from Cork Oak on WS shoulder.

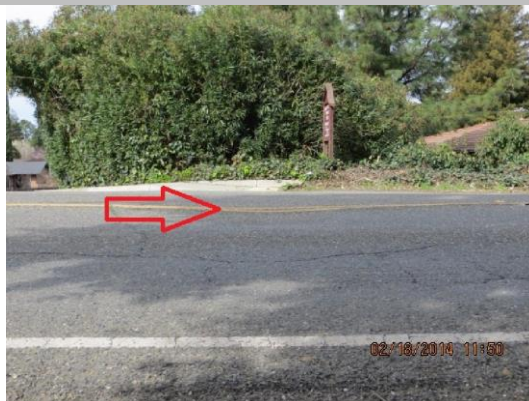
Photo 3 of 3 : UCIP_SP_2018_30345_55787.jpg

Depression over pipe alignment in crown/roadway.

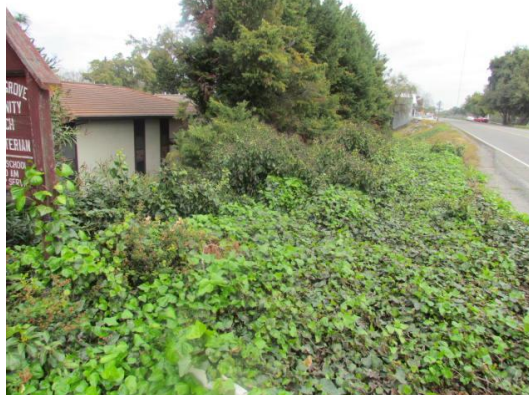
Photo 1 of 2 : SP_2018_RD0003_25_83_20180305_00071.jpg

Looking north at dense landscaping on landside shoulder and slope.

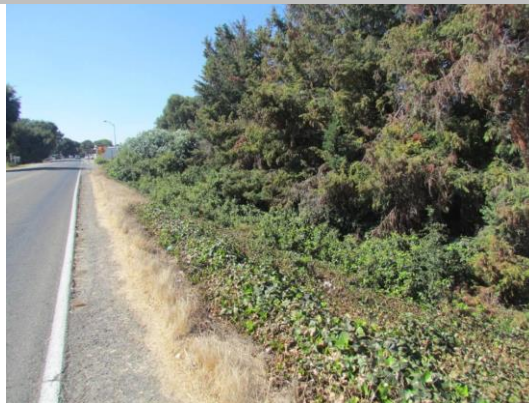
Photo 2 of 2 : SP_2018_RD0003_25_83_20180305_00072.jpg

Looking south at dense landscaping on landward shoulder and slope.

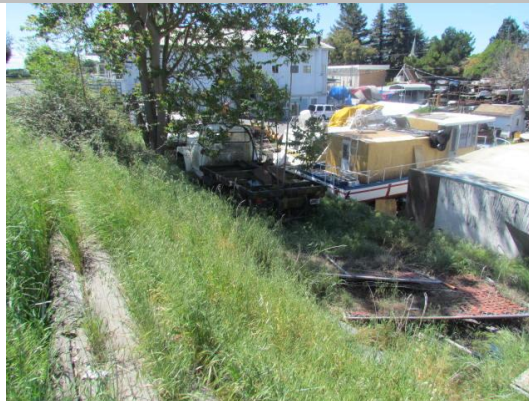
Photo 1 of 2 : SP_2018_RD0003_25_86_20180305_00075.jpg

| Abandoned vehicles and material on landside toe. | | | | | |

Looking south at abandoned vehicles and material on landward slope and toe.

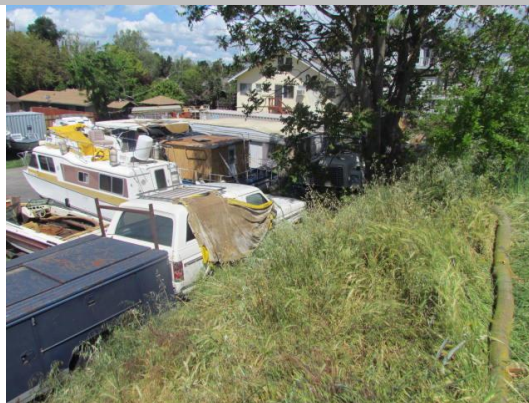
Photo 2 of 2 : SP_2018_RD0003_25_86_20180305_00076.jpg

| Abandoned vehicles and material on landside toe. | | | | | | |

Looking north at abandoned vehicles on landward toe.

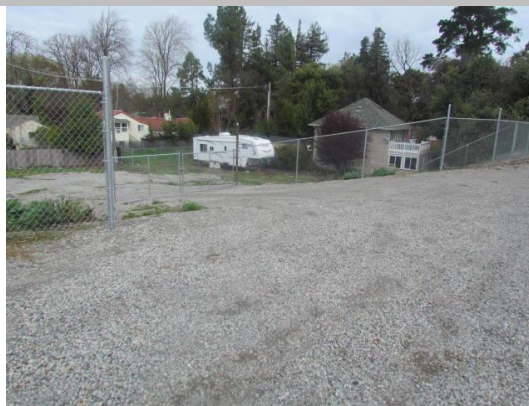
Photo 1 of 1 : SP_2018_RD0003_25_268_20180305_00147.jpg

| Landowner installed new ramp without board permit. | | | | | |

Looking north at new ramp on landside slope.

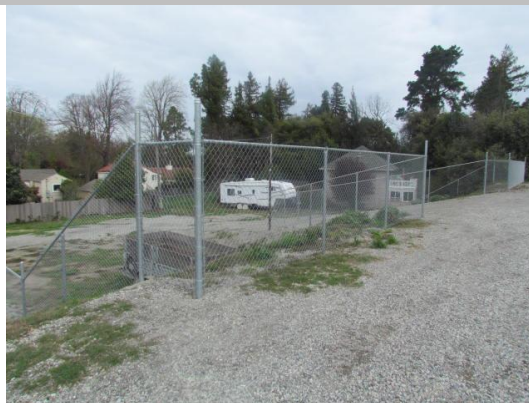
Photo 1 of 1 : SP_2018_RD0003_25_267_20180305_00146.jpg

| Landowner installed a new fence on the landside of levee. | | | | | |

Looking north at new fence on landside shoulder and slope.

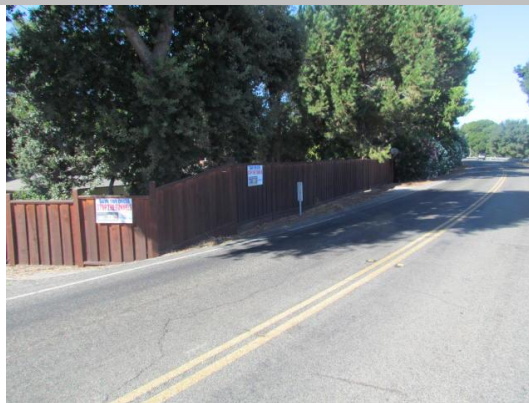
Photo 1 of 2 : SP_2018_RD0003_25_31_20180305_00033.jpg

| Landscaping and new wooden fence on landside slope. | | | | | |

Looking northwest at new wooden fence on landward shoulder.

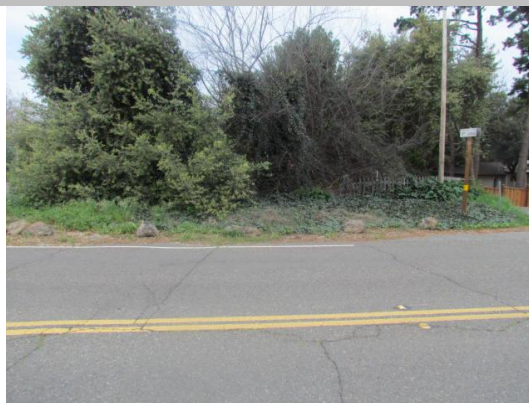
Photo 2 of 2 : SP_2018_RD0003_25_31_20180305_00034.jpg

Looking west at dense landscaping on landside shoulder and slope.

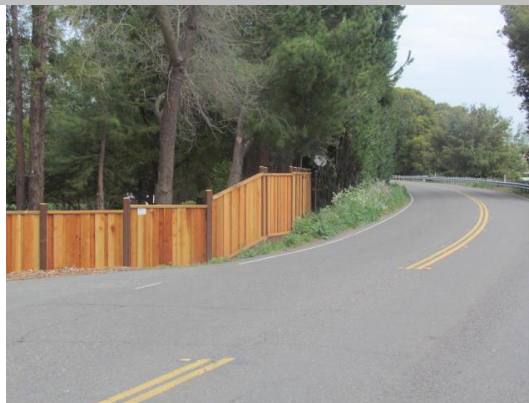
Photo 1 of 1 : SP_2018_RD0003_25_269_20180305_00148.jpg

| Landowner installed a new fence w/o permit. | | | | | |

Looking northwest at a new wooden fence on landside shoulder.

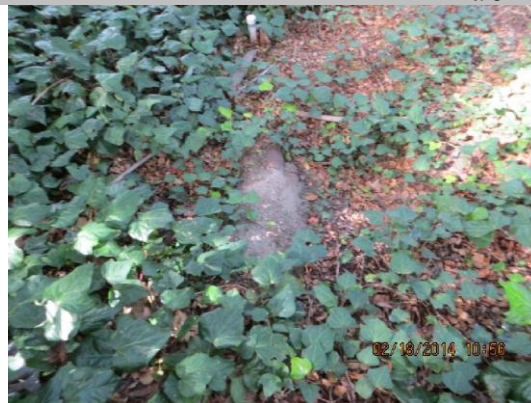
Photo 1 of 3 : UCIP_SP_2018_30306_55726.jpg

FS_ID:30306
DS_ID:22296
EP_NO: 2383
Repair Type: Non-Urgent
Crossing Status: Found
UCIP Comments: Annular space should be grouted. No permit identified for pipes sleeved through irrigation pipe.
FIELD_STRUCT_DESC: 6-inch steel irrigation discharge pipe through the levee, 4 feet below the crown. Pump and gate valve on the waterside (WS) slope. A 4-inch pipe is sleeved through the 6-inch pipe. Two conduits are sleeved through the 4-inch pipe: A 1-inch water line and a 1.5-inch electrical conduit provide service to a boat dock, 210 feet upstream from the pump. (Plans for the installation of a pump on the WS slope and a 6-inch discharge pipe through the levee, 4 feet below the crown, authorized under Permit No. 2383, 1956 - James S. and Nancy P. Moser). The 4-inch pipe and two conduits were sleeved through the 6-inch pipe at a later date and likely without a permit.
[Additional Reference(s): DWR Levee Log, 1993].

6-inch pipe visible on LS toe.

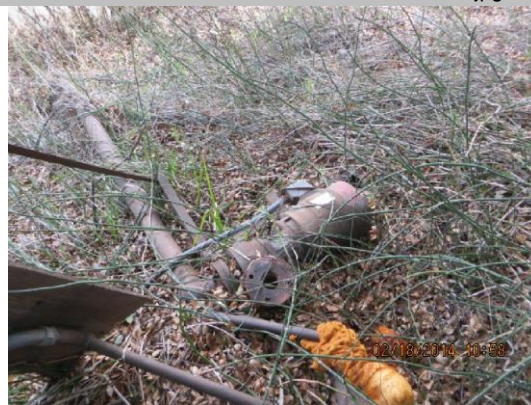
Photo 2 of 3 : UCIP_SP_2018_30306_55729.jpg

Pipe and pump visible on WS slope.

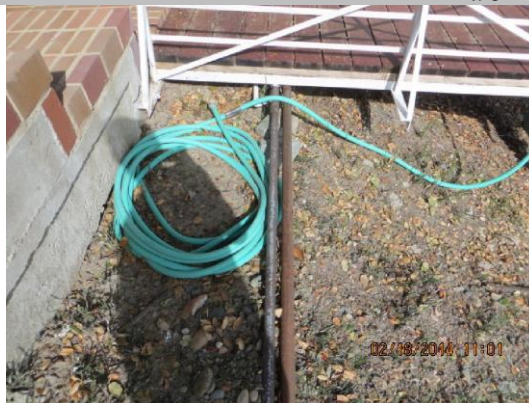
Photo 3 of 3 : UCIP_SP_2018_30306_55728.jpg

| FS_ID:30306 DS_ID:22296 EP_NO: 2383 Repair Type: Non-Urgent Crossing Status: Found UCIP Comments: Annular space should be grouted. No permit identified for pipes sleeved through irrigation pipe. FIELD_STRUCT_DESC: 6-inch steel irrigation discharge pipe through the levee, 4 feet below the crown. Pump and gate valve on the waterside (WS) slope. A 4-inch pipe is sleeved through the 6-inch pipe. Two conduits are sleeved through the 4-inch pipe: A 1-inch water line and a 1.5-inch electrical conduit provide service to a boat dock, 210 feet upstream from the pump. (Plans for the installation of a pump on the WS slope and a 6-inch discharge pipe through the levee, 4 feet below the crown, authorized under Permit No. 2383, 1956 - James S. and Nancy P. Moser). The 4-inch pipe and two conduits were sleeved through the 6-inch pipe at a later date and likely without a permit. [Additional Reference(s): DWR Levee Log, 1993]. FS Date: 2/18/2014 | | | | | | |

2-steel pipes run parallel to crown on WS slope from pump to boat walkway, 210-feet upstream from pump.

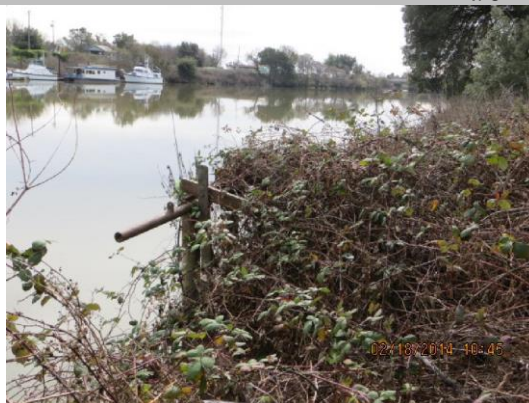
Photo 1 of 3 : UCIP_SP_2018_30305_55725.jpg

Abandoned pump platform on WS slope.

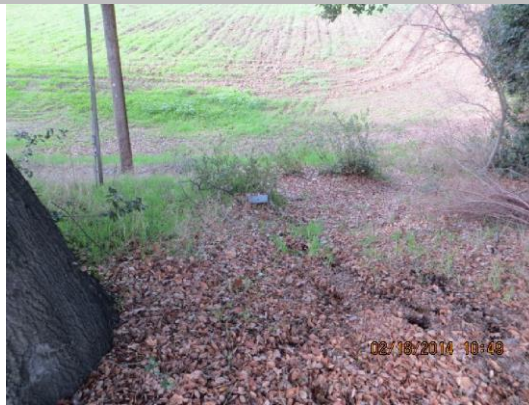
Photo 2 of 3 : UCIP_SP_2018_30305_55724.jpg

Electrical conduit, pole, and pipe remnants on LS slope.

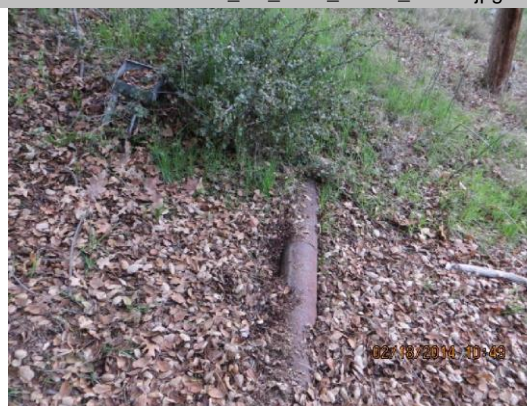
Photo 3 of 3 : UCIP_SP_2018_30305_55723.jpg

| FS_ID:30305 DS_ID:22297 EP_NO: N/A Repair Type: Non-Urgent Crossing Status: Found UCIP Comments: Pump and pipe abandoned and should be done so properly. FIELD_STRUCT_DESC: 7-inch steel irrigation discharge pipe through the levee, invert elevation 8.4 feet below the crown. Pump platform visible on the waterside (WS) slope. 1.5-inch steel electrical conduit through the levee at the same location. (H. Town). [Additional Reference(s): DWR Levee Log, 1993, 5-inch pipe referenced. USACE Sacramento O&M Manual 104, February 1960, (RM 27.29), 5-inch galvanized iron pipe referenced]. FS Date: 2/18/2014 | | | | | | |

Abandoned pipe visible on LS slope.

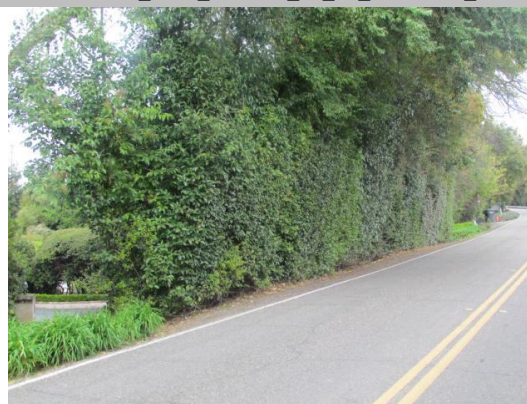
Photo 1 of 1 : SP_2018_RD0003_25_34_20180305_00037.jpg

Looking northwest at dense landscaping on landside shoulder.

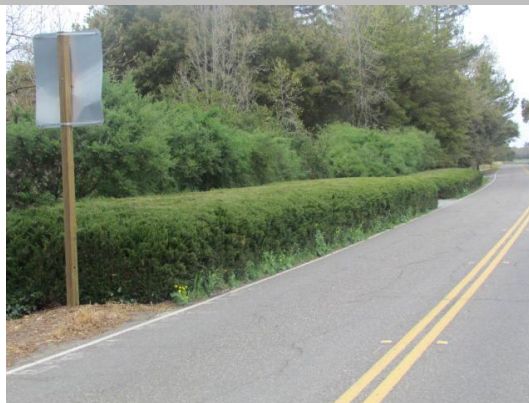
Photo 1 of 1 : SP_2018_RD0003_25_37_20180305_00039.jpg

| Dense landscaping on landside shoulder and slope. | | | | | |

Looking northwest at dense landscaping on landside shoulder and slope.

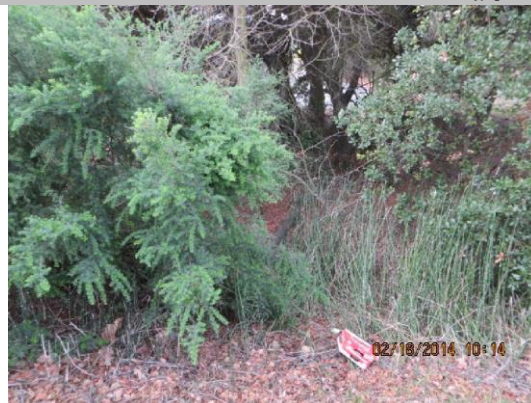
Photo 1 of 3 : UCIP_SP_2018_40544_55694.jpg

FS_ID:40544
DS_ID:22299
EP_NO: 1376
Repair Type: Non-Urgent
Crossing Status: Found
UCIP Comments: Pipe abandoned and should be done so properly.
Pipe rusted through at various locations.
FIELD_STRUCT_DESC: 12-inch steel irrigation discharge pipe through the levee, invert elevation 5 feet below the crown. Pump is missing from the waterside (WS) slope, and a steel plate is bolted over the end of the pipe. 42-inch concrete standpipe at the landside (LS) toe. 1.5-inch steel electrical conduit through the levee at the same location. (Plans for installing a vertical unit irrigation pumping plant and a 12-inch steel discharge pipe through the levee authorized under Permit No. 1376, 1949 - Joseph Gwerder Estate). [Additional Reference(s): DWR Levee Log, 1993. USACE Sacramento O&M Manual 104, February 1960, (RM 27.59)].
FS Date: 2/18/2014

Pipe visible on LS slope.

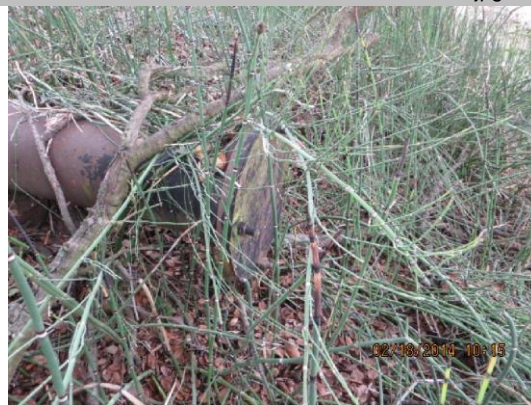
Photo 2 of 3 : UCIP_SP_2018_40544_55693.jpg

Steel plate bolted over pipe end on WS slope.

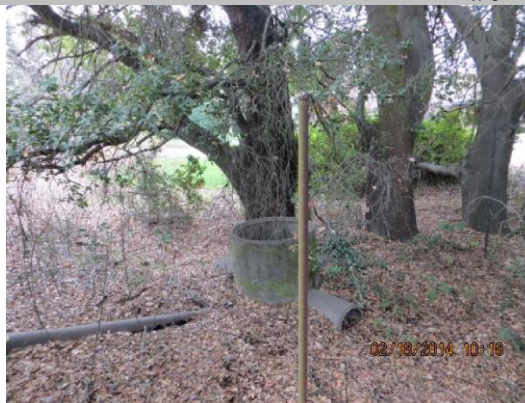
Photo 3 of 3 : UCIP_SP_2018_40544_55692.jpg

| FS_ID:40544 DS_ID:22299 EP_NO: 1376 Repair Type: Non-Urgent Crossing Status: Found UCIP Comments: Pipe abandoned and should be done so properly. Pipe rusted through at various locations. FIELD_STRUCT_DESC: 12-inch steel irrigation discharge pipe through the levee, invert elevation 5 feet below the crown. Pump is missing from the waterside (WS) slope, and a steel plate is bolted over the end of the pipe. 42-inch concrete standpipe at the landside (LS) toe. 1.5-inch steel electrical conduit through the levee at the same location. (Plans for installing a vertical unit irrigation pumping plant and a 12-inch steel discharge pipe through the levee authorized under Permit No. 1376, 1949 - Joseph Gwerder Estate). [Additional Reference(s): DWR Levee Log, 1993. USACE Sacramento O&M Manual 104, February 1960, (RM 27.59)]. FS Date: 2/18/2014 | | | | | |

Concrete standpipe on LS toe.

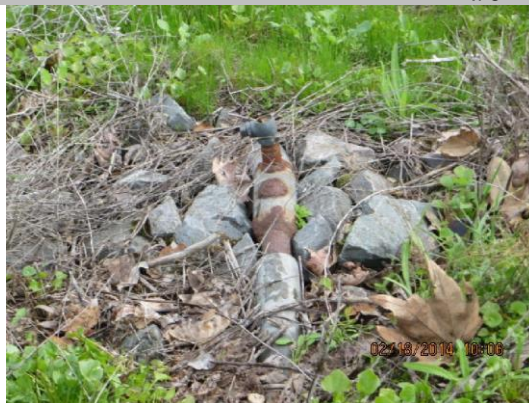
Photo 1 of 3 : UCIP_SP_2018_30286_55689.jpg

| UCIP Comments: Appears abandoned and if so should be done so properly. Vent broken off pipe on both shoulders. | | | | | | |

Pipe visible on WS slope with broken vent.

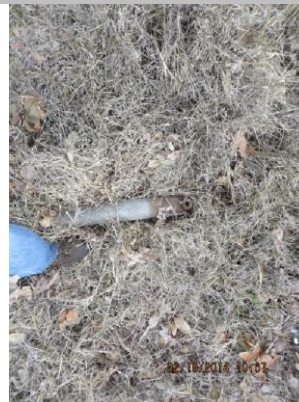
Photo 2 of 3 : UCIP_SP_2018_30286_55688.jpg

Pipe visible on LS slope with broken vent.

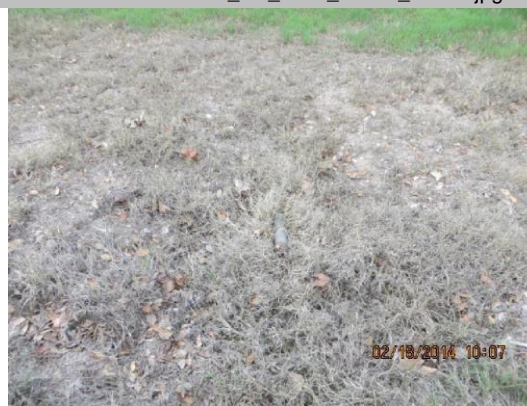
Photo 3 of 3 : UCIP_SP_2018_30286_55687.jpg

| UCIP Comments: Appears abandoned and if so should be done so properly. Vent broken off pipe on both shoulders. | | | | | | |

Pipe visible on LS slope.

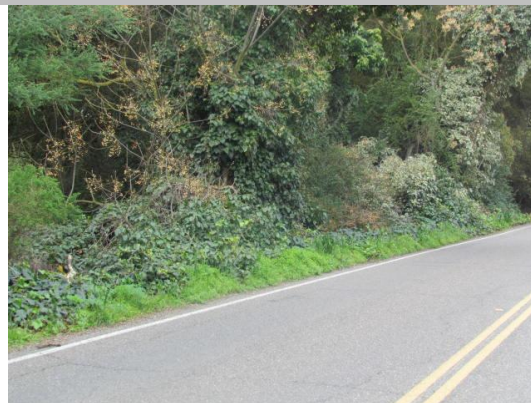
Photo 1 of 1 : SP_2018_RD0003_25_82_20180305_00070.jpg

| Dense landscaping blocking view of landside slope and toe. | | | | | |

Looking west at dense landscaping on landside shoulder and slope.

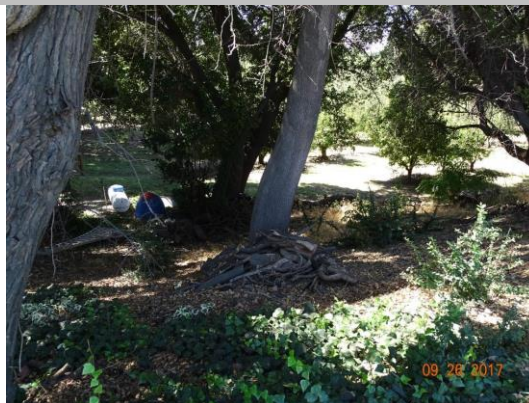
Photo 1 of 1 : SP_2018_RD0003_25_133_20180305_00099.jpg

| Debris and prunings at landside toe. | | | | | |

Looking southwest at the landside slope.

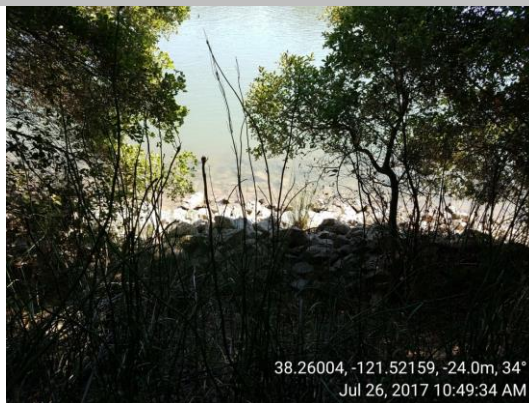
Photo 1 of 3 : SP_2018_RD0003_25_139_20180305_00109.jpg

| Levee Evaluation Comments Description:District station 694+80 to 695+69, Sec. 27, 1. 5 N. R. 4 E., M.D.M. Approximately 89 linear feet of erosion and sloughing exists along the water side slope of the Sacramento River (Unit 2). The erosion commences approximately 1/2 of the way down the slope from the crown and extends into the rip rap. Site ID No:281 Site Designation:LMA-107 Repair Type: Erosion Rating:Area of Concern Field Date:7/26/2017 Notes: | | | | | |

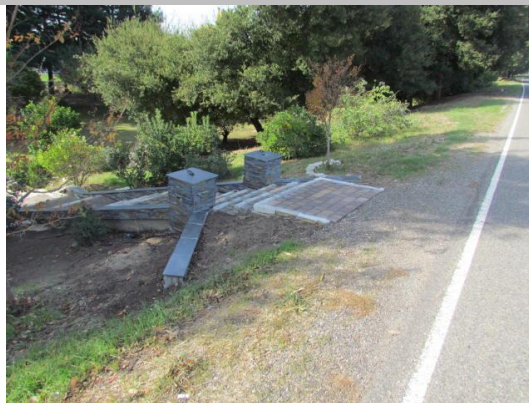
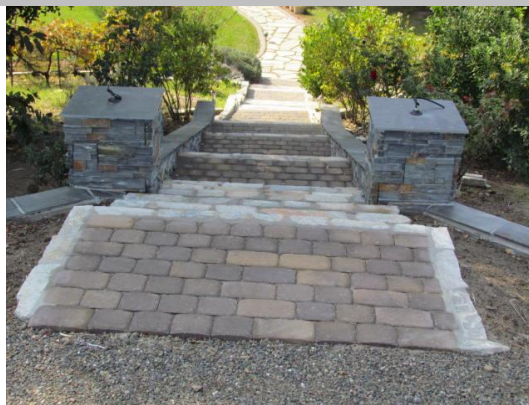
| Landowner installed unauthorized stairs on landside slope. No permit on record. | | | | | |

Looking northwest at stairs on landside slope.

Looking west at stairs on landside slope.

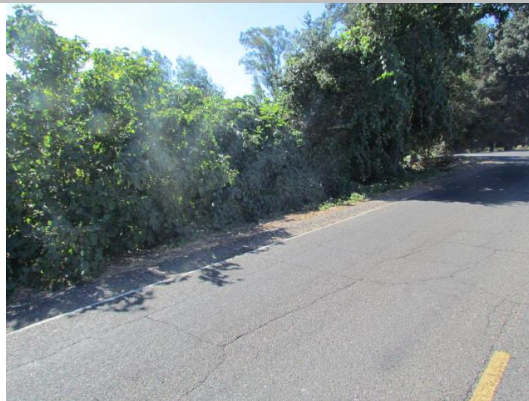
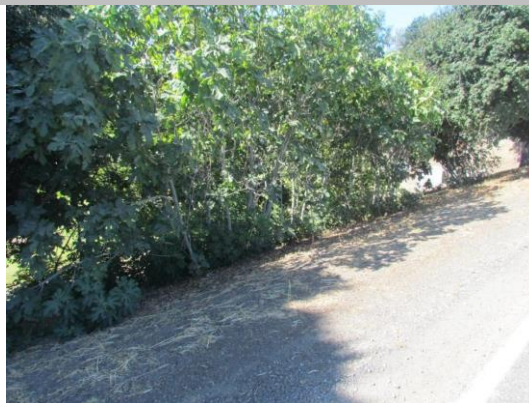
Looking westly at dense vegetation on landward shoulder and slope.
(Spring 2016)

Looking westly at fig trees on landward slope. (Fall 2016)

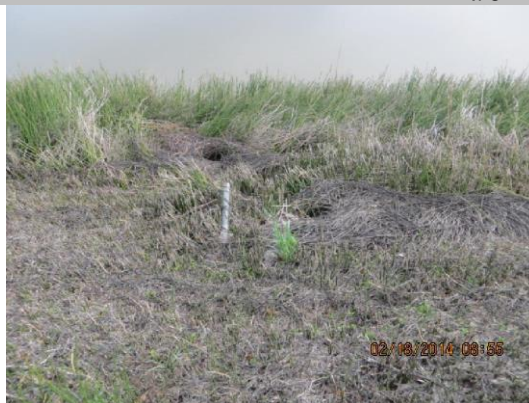
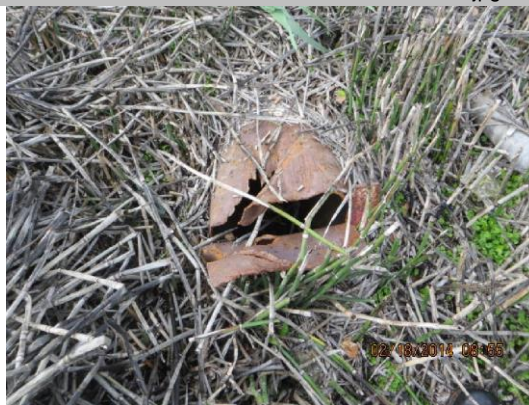
| FS_ID:41585 DS_ID:22306 EP_NO: N/A Repair Type: Non-Urgent Crossing Status: Found UCIP Comments: Steel plate broken and pipe open on WS slope. Pipe abandoned and should be done so properly. FIELD_STRUCT_DESC: *ABANDONED* 12-inch steel irrigation pipe through the levee, 6 feet below the crown. (Steel plate welded on the waterside [WS] end by USACE, Unit 15, in 1969). [Additional Reference(s): DWR Levee Log, 1993]. FS Date: 2/18/2014 | | | | | |

Pipe visible on WS slope.

Pipe open on WS slope.

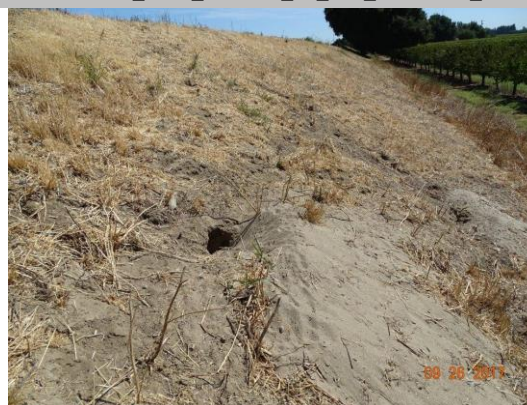
Looking southeast at the landside slope.

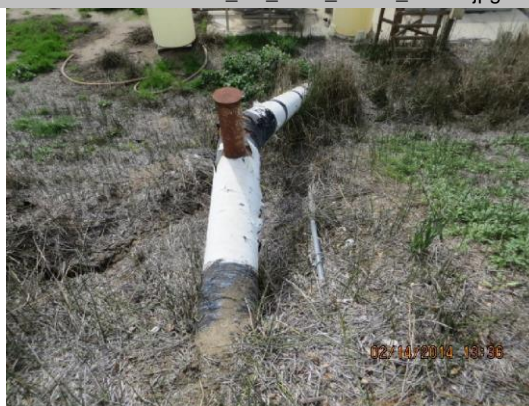
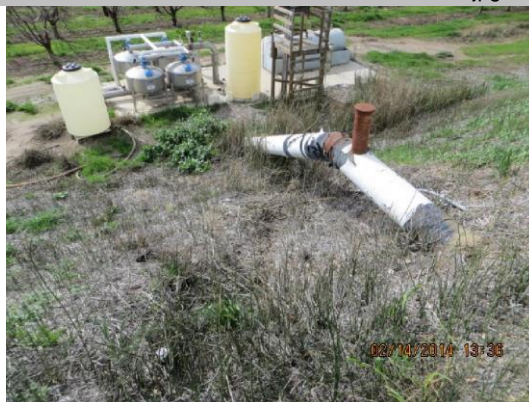
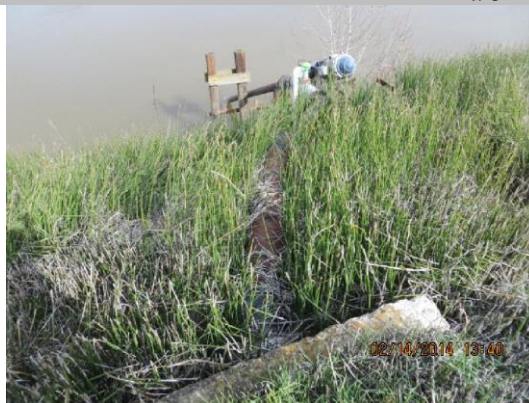
| FS_ID:30203 DS_ID:22308 EP_NO: N/A Repair Type: Non-Urgent Crossing Status: Found UCIP Comments: Erosion next to pipe on LS slope. FIELD_STRUCT_DESC: 16-inch steel irrigation discharge pipe through the levee, 3 feet below the crown. 14-inch pipe sleeved through the 16-inch pipe and a 1.5-inch steel electrical conduit at the same location. Slant pump on the waterside (WS) slope and a filter plant at the landside (LS) toe. [Additional Reference(s): DWR Levee Log, 1993, referenced as 5.6 feet below the crown. USACE Sacramento O&M Manual 104, February 1960, (RM 28.91), referenced as invert elevation 5.6 feet below the crown]. FS Date: 2/14/2014 | | | | | |

Pipe, vent, and electrical conduit visible on LS slope.

Erosion in foreground with pipe and filter plant in background.

Concrete headwall, pipe, and slantpump on WS slope.

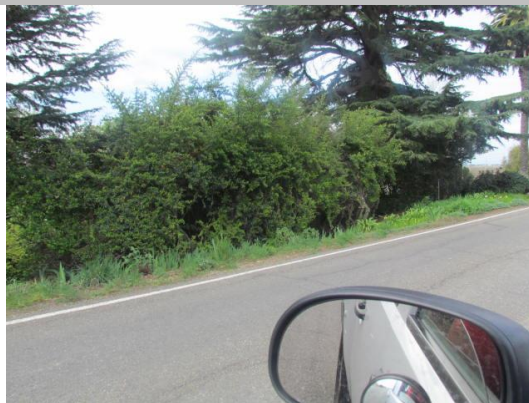
Looking west at landscaping on landside slope.

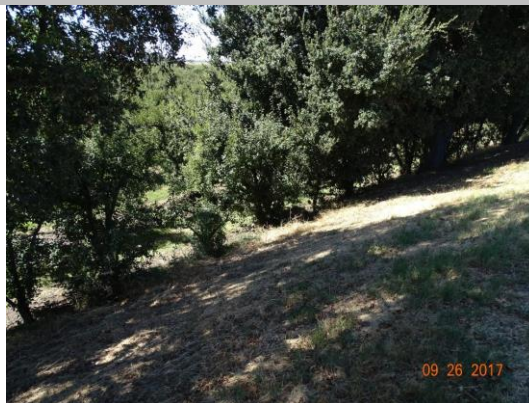
| Landowner has planted pear trees trees at the toe of the levee. | | | | | |

Looking northwest at the landside slope.

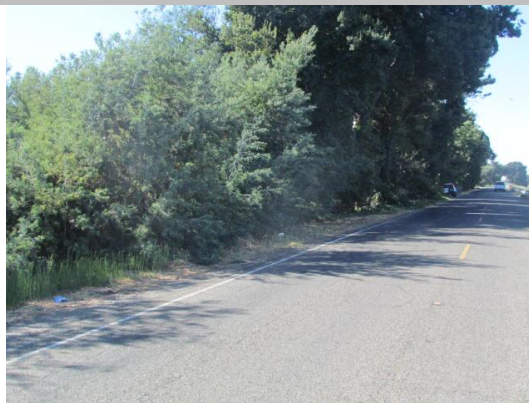
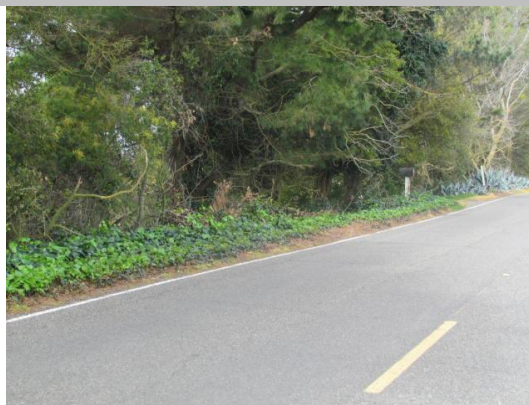
Looking westly at dense landscaping on landward shoulder and slope.

Looking northwest at dense landscaping on landside shoulder and slope.
